DEPARTMENT OF TRANSPORTATION**DIVISION OF ENGINEERING SERVICES**

Quality Assurance and Source Inspection

Contract #: 04-0120F4Cty: SF/ALA Rte: 80 PM: 13.2/13.9File #: 1.28**WELDING INSPECTION REPORT****Resident Engineer:** Pursell, Gary**Address:** 333 Burma Road**City:** Oakland, CA 94607**Report No:** WIR-012477**Date Inspected:** 09-Mar-2010**Project Name:** SAS Superstructure**OSM Arrival Time:** 1300**Prime Contractor:** American Bridge/Fluor Enterprises, a JV**OSM Departure Time:** 2130**Contractor:** American Bridge/Fluor Enterprises, a JV**Location:** Job Site**CWI Name:** See Below**CWI Present:** Yes No**Inspected CWI report:** Yes No N/A**Rod Oven in Use:** Yes No N/A**Electrode to specification:** Yes No N/A**Weld Procedures Followed:** Yes No N/A**Qualified Welders:** Yes No N/A**Verified Joint Fit-up:** Yes No N/A**Approved Drawings:** Yes No N/A**Approved WPS:** Yes No N/A**Delayed / Cancelled:** Yes No N/A**Bridge No:** 34-0006**Component:** Orthotropic Box Girders**Summary of Items Observed:**

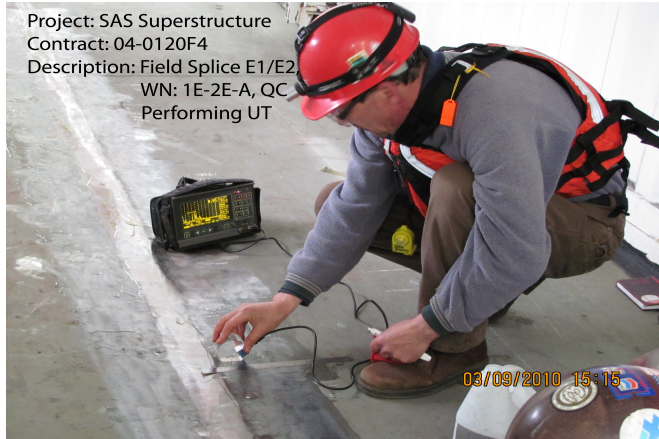
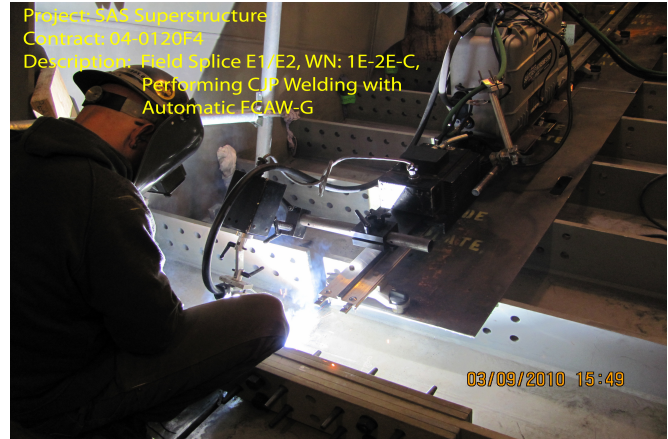
The QA inspector observed the FCAW-G of the E1/E2 field splice utilizing the WPS's as noted above which appeared to be posted at the weld station. The welding parameters and preheat temperatures were verified and noted utilizing a Fluke 337 clamp meter for the electrical welding parameters and a Fluke 63 IR Thermometer for verifying the preheat and interpass temperatures. The consumables utilized during the groove welding appeared to be an ESAB manufactured product identified as ESAB Dual Shield 70 Ultra Plus with a size of 1.4mm which appeared to comply with the AWS Electrode Specification AWS A5.20 and the AWS Classification E71T-1M. The welding, QC inspection and UT performed on this shift was not completed except as noted above and appeared to be in general compliance with the contract documents. The QAI randomly verified the QC inspection, the welding parameters and surface temperatures utilizing various inspection equipment and gages, a Fluke 337 Clamp Meter and Tempilstik Temperature indicators.

See digital photographs located on Page 3 of this report in regards to the work observed during this shift.
